**NUMBER:** 02-001-15

**GROUP:** Front Suspension

Shock Strut Weeping Condition Identification

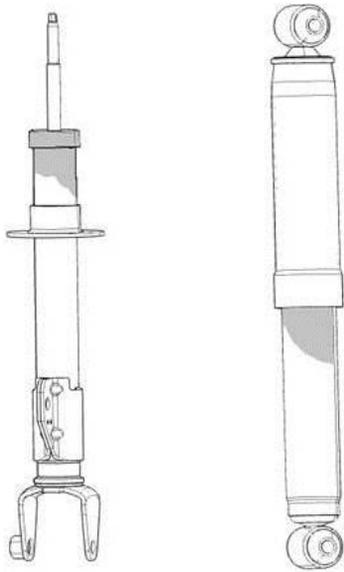
Light fluid film in the top one-third of the strut/shock is considered normal (Fig. 1). Strut/Shock replacement not recommended, provided the strut/shock is functioning (dampening) as designed.

**Fig. 1 Light Fluid Film - Replacement Not Recommended**

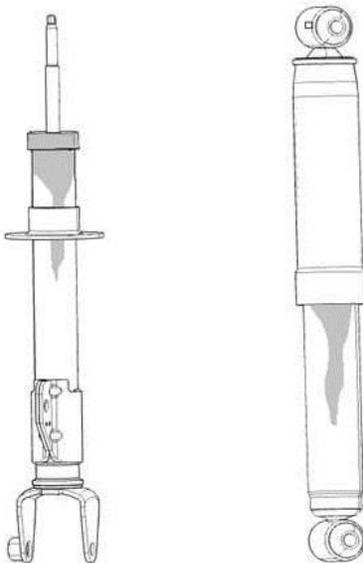
Minor weep - drops of shock fluid extending down beyond one-third or more of the strut/shock body length (Fig. 2). Strut/Shock replacement is recommended.

**Fig. 2 Minor Weep - Replacement Recommended**

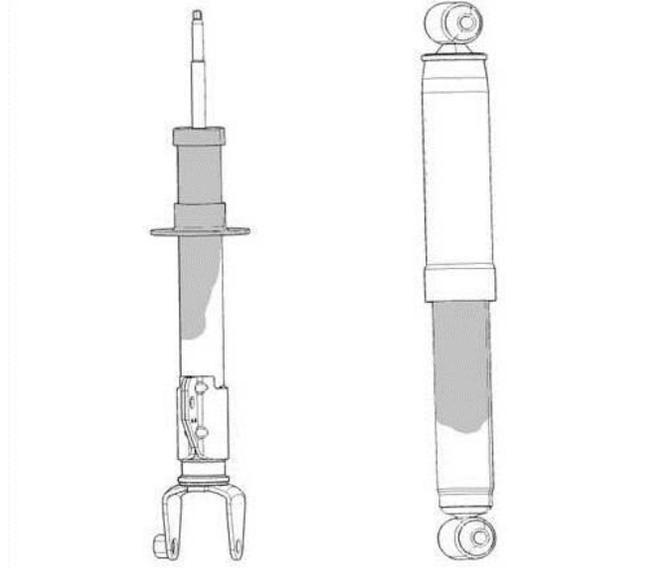
Major weep - fluid covers two-thirds or more of the strut/shock body length (Fig. 3). Strut/Shock replacement is recommended.

***Fig. 3 Major Weep - Replacement Recommended***
