NUMBER: 08-016-18

DATE: February 2, 2018

RG3 RG4 RJ3 RJ4 Radio Enhancements

This bulletin involves inspecting and if required, updating the radio software.

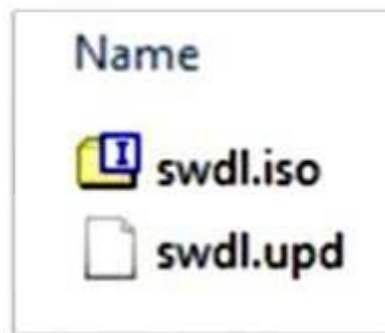
Fig. 1
Two USB Files

NOTE: Two files will be loaded onto the USB flash drive (Fig. 1) .

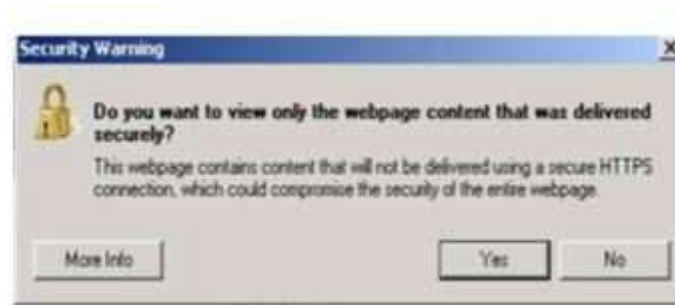
Fig. 2
Pop-up Security Message

3. If a security message appears “Do you want to view only the web page content that was delivered securely? (Fig. 2) Press No to continue.

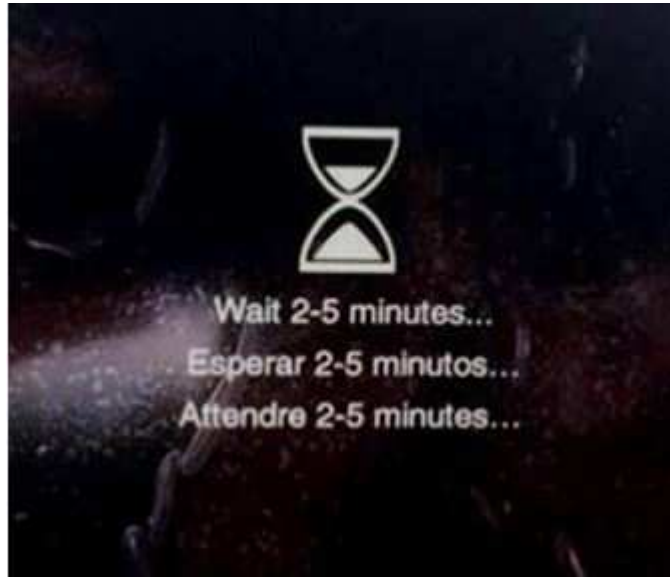
Fig. 3
Hourglass Screen

NOTE: During the update process you will see multiple hourglass and “Please Insert Update USB” screens for extended periods of time (several minutes) (Fig. 3) or (Fig. 4) . DO NOT remove the USB flash drive at this time. Only remove the USB flash drive when the update has completed, when the screen displays the software levels again. The screen will say “Software updated successfully”.

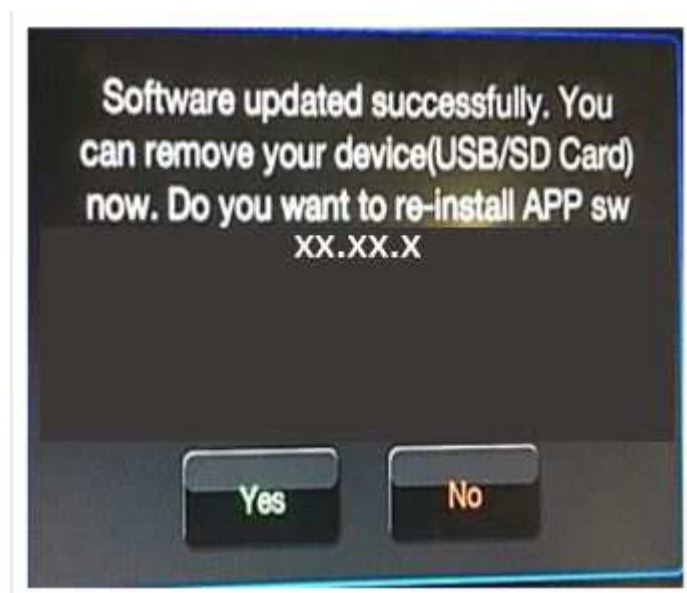
Fig. 5
Software Updated Successfully

10. After the update is done, the screen will display the software levels again and will prompt the technician to remove USB flash drive, see (Fig. 5) .
