NUMBER: 08-019-17 REV. A

GROUP: 08 - Electrical

DATE: June 17, 2017

RG3 RG4 RJ3 RJ4 Radio Enhancements

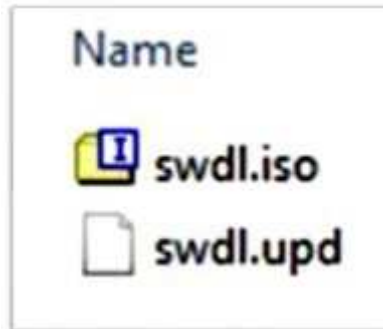
Fig. 1
Two USB Files

NOTE: Two files will be loaded onto the USB flash drive (Fig. 1) .

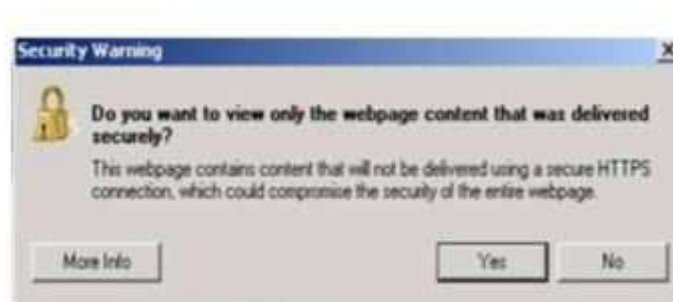
Fig. 2
Pop-up Security Message

1. Has a USB flash drive been created?
 - a. YES >>> Proceed to [Step 2](#).
 - b. NO >>> Proceed to [Step 5](#).
2. Go to DealerCONNECT> Service> Uconnect Information & Utilities> Uconnect Dealer software downloads to download the files.
3. If a security message appears “Do you want to view only the web page content that was delivered securely? (Fig. 2) Press No to continue.

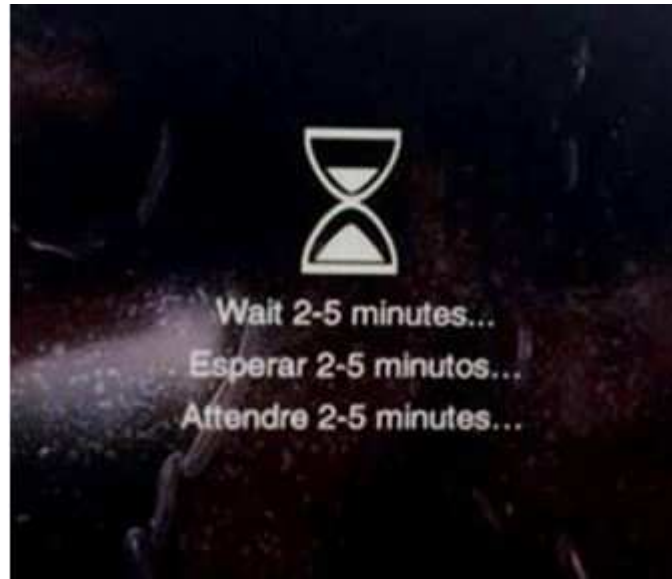
**Fig. 3
Hourglass Screen**

NOTE: **During the update process you will see multiple hourglass and “Please Insert Update USB” screens for extended periods of time (several minutes) (Fig. 3) or (Fig. 4) . DO NOT remove the USB flash drive at this time. Only remove the USB flash drive when the update has completed, when the screen displays the software levels again. The screen will say “Software updated successfully”.**

NOTE: During the update process, the screen on the radio will display an hourglass and blue screen that said "Please Insert Update USB" for approximately two to five minutes at a time ([Fig. 3](#)) and ([Fig. 4](#))

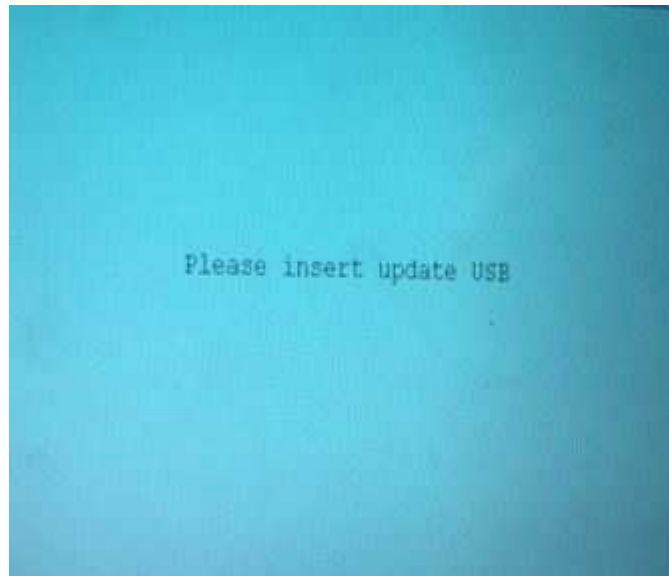
Fig. 4

****Please Insert Update USB****

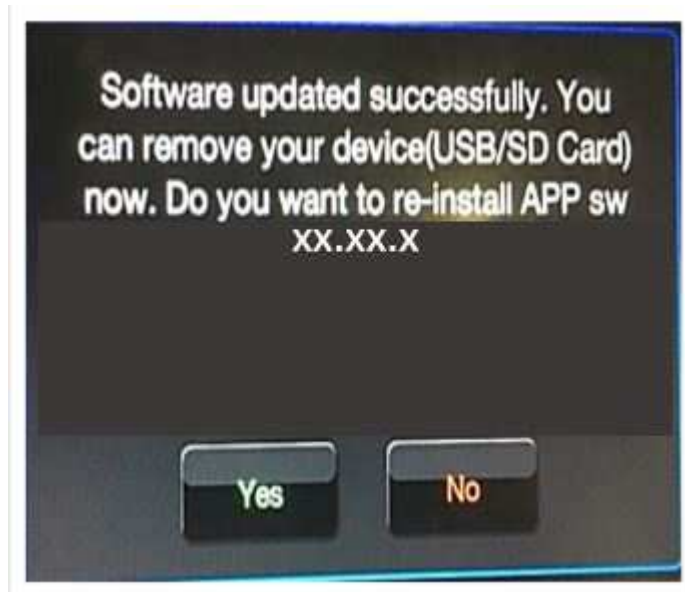
Fig. 5

12. **After the update is done the screen will display the software levels again and will prompt to remove USB (Fig. 5) .**

****Software Updated Successfully****
