**NUMBER:** 08-035-18 REV. B

**GROUP:** 08 - Electrical

**DATE:** May 9, 2018

RJ3 RJ4 RG3 and RG4 Radio Enhancements

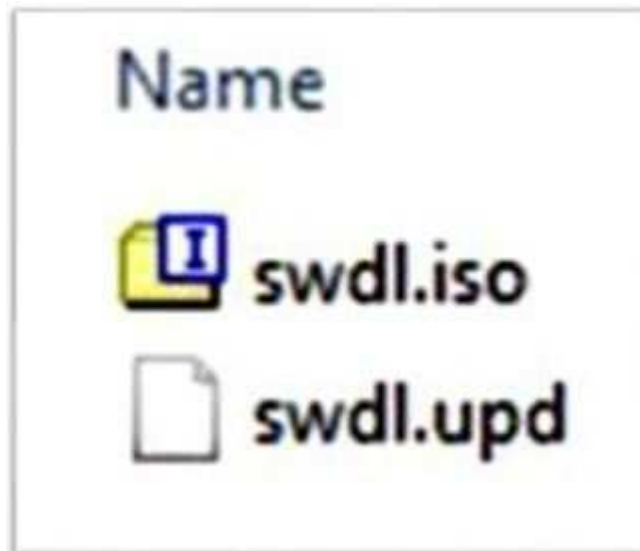
Fig. 1  
Two USB Files

**NOTE:** Two files will be loaded onto the USB flash drive (Fig. 1) .

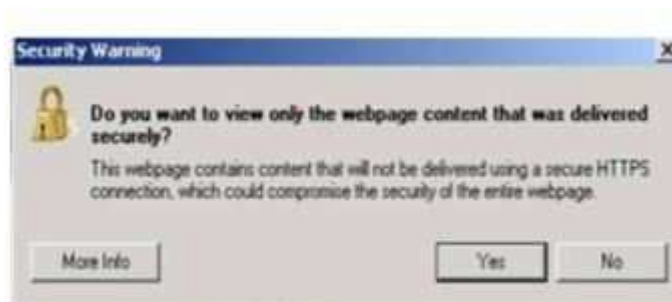
Fig. 2  
Pop-up Security Message

3. If a security message appears “Do you want to view only the web page content that was delivered securely?” (Fig. 2) . Press “No” to continue.

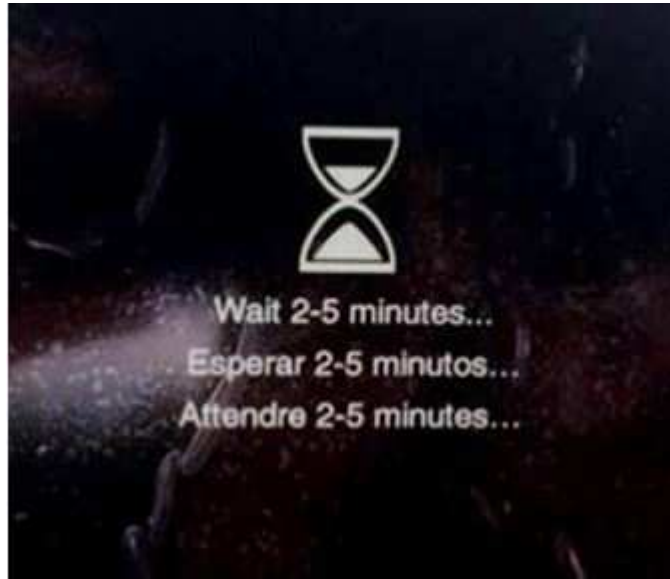
**Fig. 3**  
**Hourglass Screen**

**NOTE:** During the update process you will see multiple hourglass and “Please Insert Update USB” screens for extended periods of time (several minutes) (Fig. 3) or (Fig. 4) . DO NOT remove the USB flash drive at this time. Only remove the USB flash drive when the update has completed, when the screen displays the software levels again. The screen will say “Software updated successfully”.

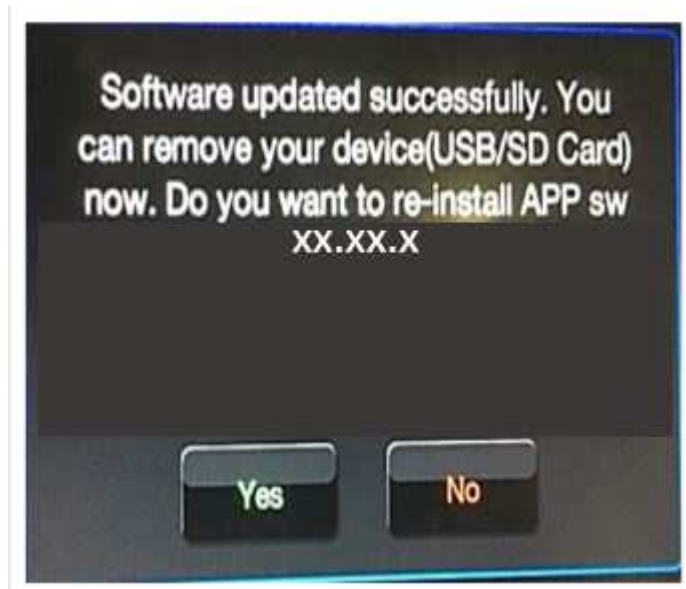
Fig. 5

10. After the update is done, the screen will display the software levels again and will prompt to remove USB ([Fig. 5](#)) .

Software Updated Successfully
