NUMBER: 08-046-17

GROUP: 08 - Electrical

DATE: June 8, 2017

RA3 and RA4 Radio Enhancements

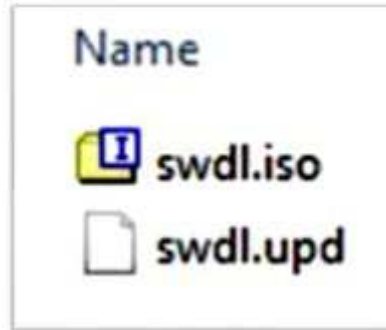
Fig. 1
Two USB Files

NOTE: Two files will be loaded onto the USB flash drive (Fig. 1) .

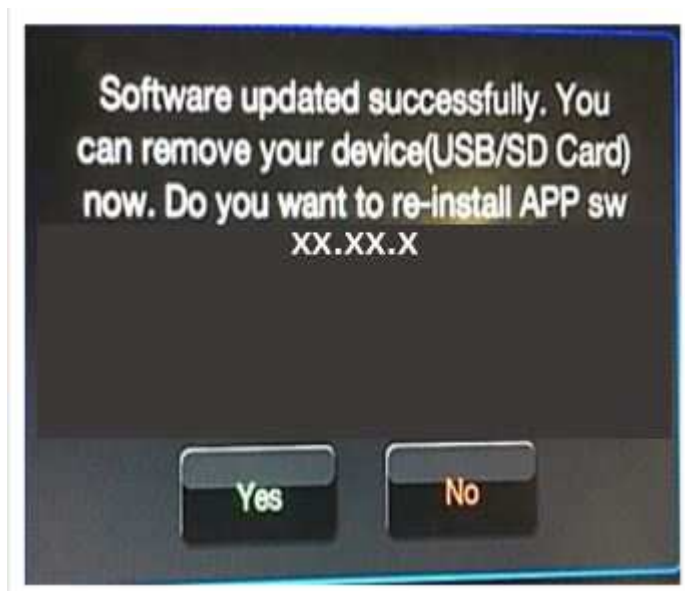
Fig. 5

10. ****After the update is done the screen will display the software levels again and will prompt to remove USB ([Fig. 5](#)) .****

****Software Updated Successfully****
