NUMBER: 08-046-18 REV. A

GROUP: 08 - Electrical

DATE: August 18, 2018

RA3 and RA4 Radio Enhancements

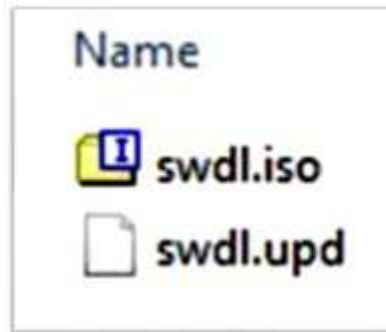
Fig. 1
Two USB Files

NOTE: Two files will be loaded onto the USB flash drive (Fig. 1) .

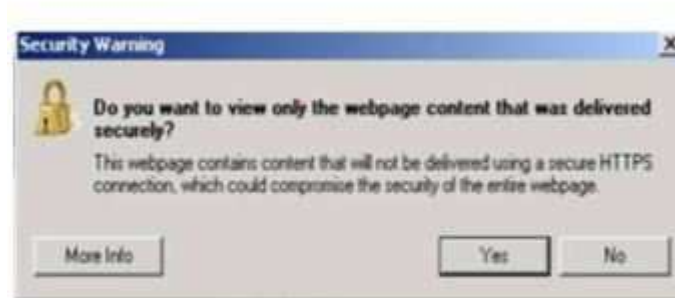
Fig. 2
Pop-up Security Message

1. Has a USB flash drive been created?
 - a. YES >>> Proceed to [Step 2](#).
 - b. NO >>> Proceed to [Step 5](#).
2. Go to DealerCONNECT> Service> Uconnect Information & Utilities> Uconnect Dealer software downloads to download the files.
3. If a security message appears “Do you want to view only the web page content that was delivered securely?” (Fig. 2) Press “No” to continue.

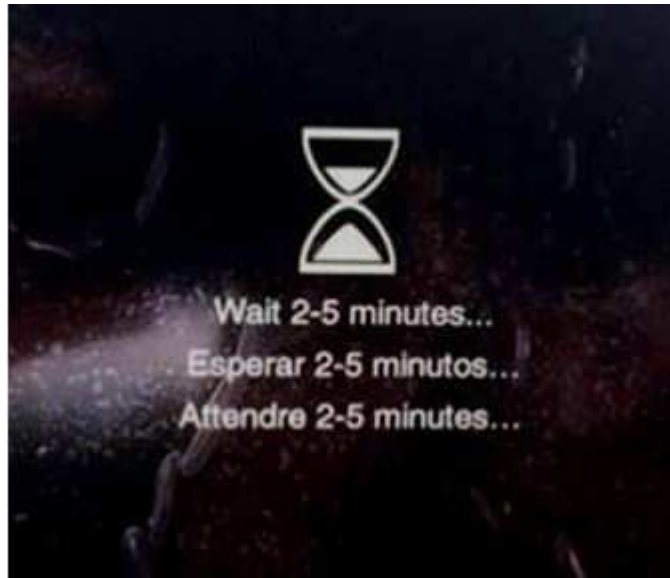
Fig. 3
Hourglass Screen

NOTE: During the update process you will see multiple hourglass and “Please Insert Update USB” screens for extended periods of time (several minutes)(Fig. 3) or (Fig. 4) . **DO NOT** remove the USB flash drive at this time. Only remove the USB flash drive when the update has completed, when the screen displays the software levels again. The screen will say “Software updated successfully”.

NOTE: During the update process, the screen on the radio will display an hourglass and blue screen that said “Please Insert Update USB” for approximately two to five minutes at a time ([Fig. 3](#)) and ([Fig. 4](#)) .

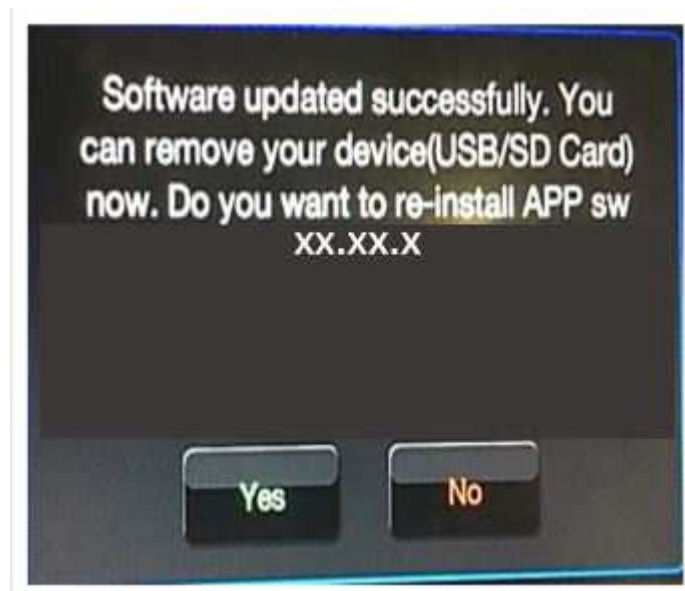
**Fig. 5
Software Updated Successfully**

10. After the update is done the screen will display the software levels again and will prompt to remove USB ([Fig. 5](#)) .
