NUMBER: 08-047-17

GROUP: 08 - Electrical

DATE: June 10, 2017

Flash: RA3/RA4 Radio Software Enhancements

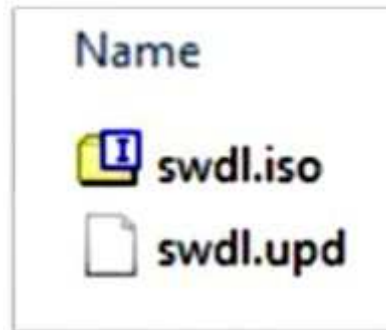
Fig. 1
Two USB Files

NOTE: Two files will be loaded onto the USB flash drive (Fig. 1) .

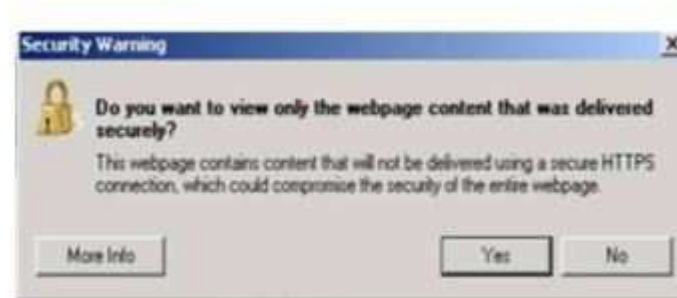
Fig. 2
Pop-up Security Message

1. Has a USB flash drive been created?
 - a. YES >>> Proceed to [Step 2](#).
 - b. NO >>> Proceed to [Step 5](#).
2. Go to DealerCONNECT> Service> Uconnect Information & Utilities> Uconnect Dealer software downloads to download the files.
3. If a security message appears “Do you want to view only the web page content that was delivered securely?” (Fig. 2) Press No to continue.
