NUMBER: 08-054-16

DATE: April 29, 2016

SUBJECT:
RA3 RA4 Radio Enhancements

OVERVIEW:
This bulletin involves inspecting and updating the radio software, if required.

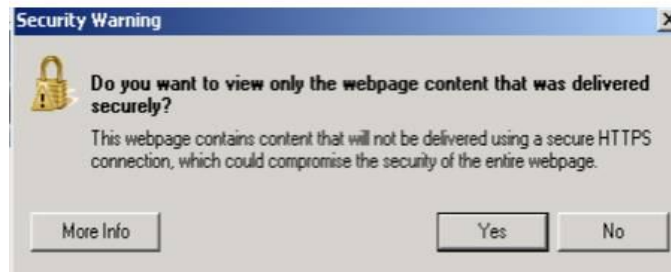
Fig. 1 Pop-up Security Message

If this Pop-up appears, select “NO” to continue.

1. Has the USB flash drive been created?
 - a. Yes >>> Proceed to [Step #4](#).
 - b. No >>> Proceed to [Step #2](#).
2. Go to DealerCONNECT> Service> UCONNECT Information & Utilities> Uconnect Dealer software downloads to download the files.
3. If a security message appears “Do you want to view only the web page content that was delivered securely?” press “NO” to continue, see ([Fig. 1](#)).
