NUMBER: 08-124-18 REV. A

Flash: Body Control Module (BCM) Updates

2017 (WK) Jeep Grand Cherokee

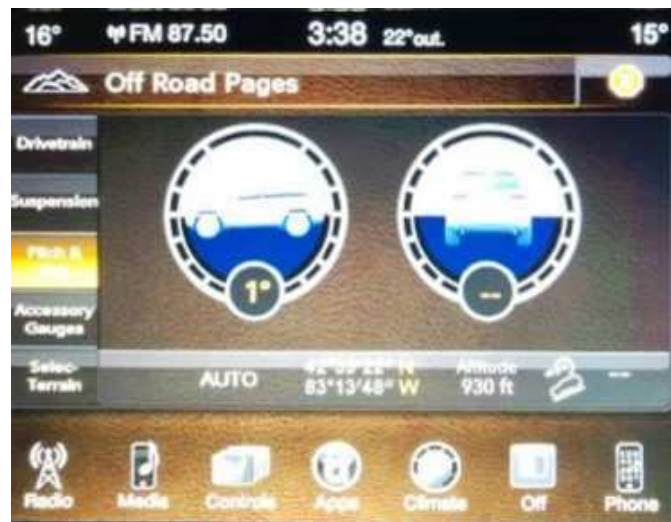
Fig. 1

Confirming One Degree Pitch or Roll Values Screen

7. Drive the vehicle to an area with a slope that has a minimum of one degree of either pitch or roll.
8. Launch the "Off Road" pages application.
9. Confirm "Pitch and Roll" Menu under the "Off Road" pages application.
10. Confirm Pitch and Roll values in the app. screen (Fig. 1) .
