NUMBER: 11-001-12

GROUP: Exhaust System

Exhaust System Leak At Turbo Face Seal

2011 (WK) Grand Cherokee (International Only)

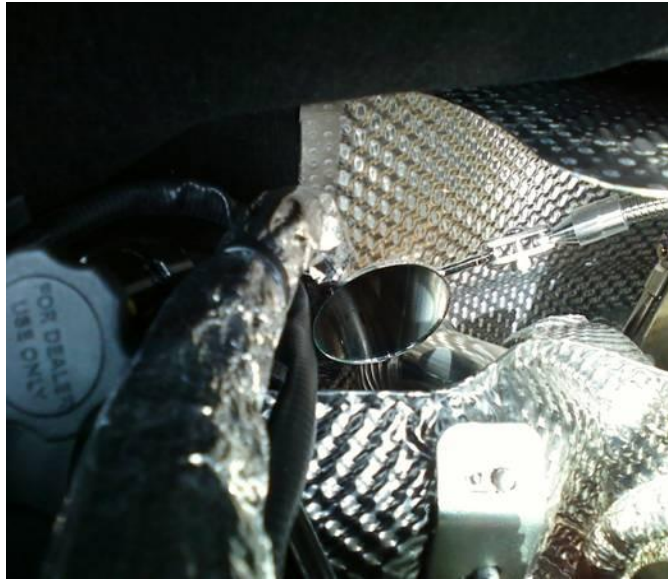
Fig. 1 Inspection

1. Raise the hood and remove engine cover.
2. Start vehicle and inspect the turbo outlet gasket for exhaust smoke or black soot (Fig. 1) and (Fig. 2)

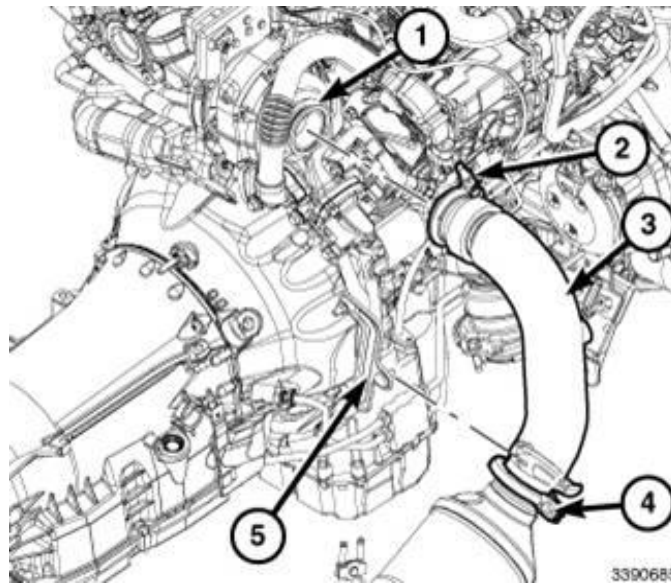
Fig. 2 Exhaust Clamp Locations

- 1 - Turbo Outlet Gasket (Look For Leaks Here)
- 2 - Turbo Outlet clamp
- 3 - Exhaust Down Pipe
- 4 - Clamp
- 5 - Bracket

-
- 3. Is the turbo exhaust gasket leaking (Fig. 2)?
 - a. Yes >>> Perform the repair procedure.
 - b. No >>> Install engine cover and return the vehicle to the customer or dealer lot.

- 1. Remove the turbo outlet clamp and gasket and discard (Fig. 2).
- 2. Install new gasket over exhaust pilot flange.
- 3. Position new exhaust clamp over the exhaust inlet flange and turbo outlet.
- 4. Ensure the exhaust is held firmly against turbo housing before securing clamp.
- 5. Secure clamp to 25 Nm.
- 6. Install engine cover.
