NUMBER: 08-035-18

GROUP: 08 - Electrical

RJ3 RJ4 Radio Enhancements

This bulletin involves inspecting and updating the radio software, if required.

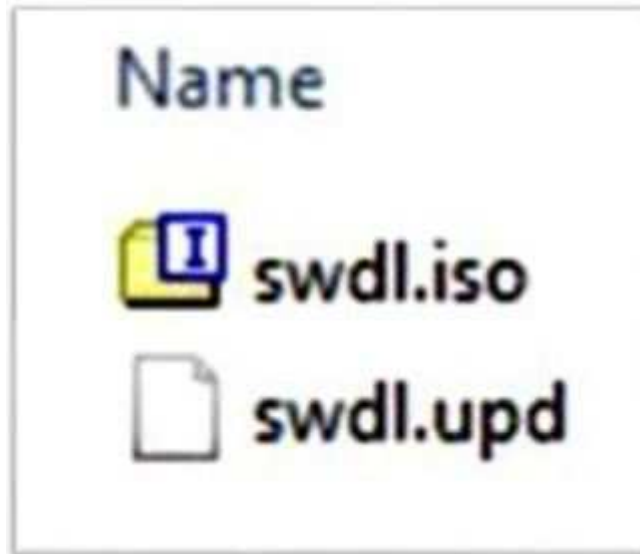
Fig. 1
Two USB Files

NOTE: Two files will be loaded onto the USB flash drive (Fig. 1) .

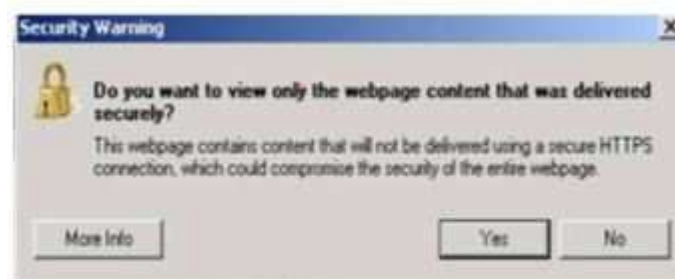
Fig. 2
Pop-up Security Message

1. Has a USB flash drive been created?
 - YES >>> Proceed to [Step 5](#).
 - NO >>> Proceed to [Step 2](#).
2. Go to DealerCONNECT> Service> Uconnect Information & Utilities> Uconnect Dealer software downloads to download the files.
3. If a security message appears “Do you want to view only the web page content that was delivered securely?” (Fig. 2) Press “No” to continue.

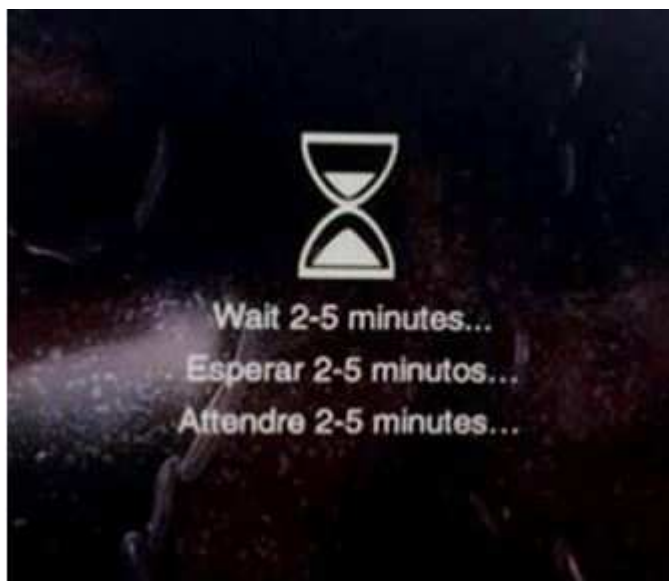
**Fig. 3
Hourglass Screen**

NOTE: During the update process you will see multiple hourglass and “Please Insert Update USB” screens for extended periods of time (several minutes) (Fig. 3) or (Fig. 4) . DO NOT remove the USB flash drive at this time. Only remove the USB flash drive when the update has completed, when the screen displays the software levels again. The screen will say “Software updated successfully”.

NOTE: During the update process, the screen on the radio will display an hourglass and blue screen that said "Please Insert Update USB" for approximately two to five minutes at a time (Fig. 3) and (Fig. 4) .
